# Flightfax<sup>®</sup>

## Online Report of Army Aircraft Mishaps

# Mishap Review: UH-60L Ground Taxi

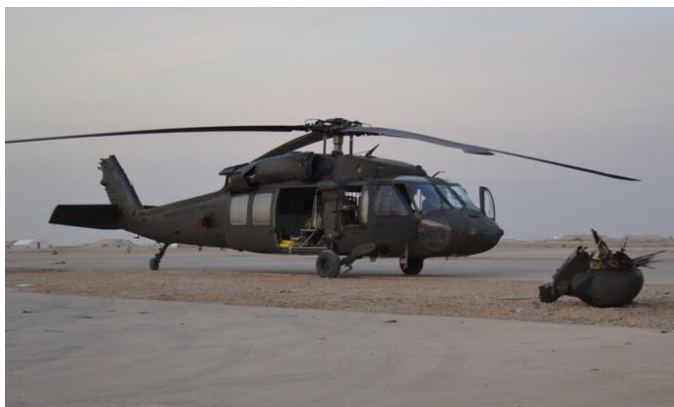
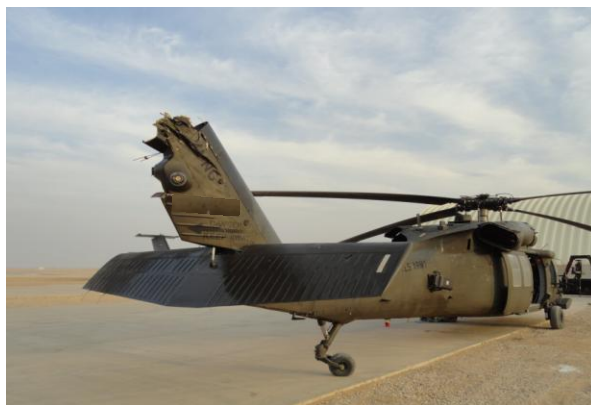
**While taxiing to parking following completion of a day air movement mission, chalk 1, in a flight of two UH-60L's, attempted a 180 degree turn on a maintenance pad and made contact with an 8' T-wall barrier. The tail strike resulted in damage to all four tail rotor paddles, separation of the tail rotor gearbox and structural damage to the tail pylon and drive train (Class B). There were no injuries.**

The accident board determined that the crew did not adequately ensure the tail was clear prior to turning and the crewchief became fixated on the tailwheel and stabilator clearance while not properly clearing the tail rotor tip path of obstacles. The crew did not properly employ all the tenets of crew coordination in that he crew did not communicate positively, announce actions, provide aircraft control and obstacle advisories, nor were they explicit in their communication procedures.
